Contract #: 04-0120F4Cty: SF/Ala Rte: 80 PM: 13.2/13.9File #: 69.28**WELDING INSPECTION REPORT****Resident Engineer:** Pursell, Gary**Address:** 333 Burma Road**City:** Oakland, CA 94607**Report No:** WIR-014494**Date Inspected:** 29-May-2010**Project Name:** SAS Superstructure**OSM Arrival Time:** 1900**Prime Contractor:** American Bridge/Fluor Enterprises, a JV**OSM Departure Time:** 700**Contractor:** Zhenhua Port Machinery Company, Ltd (ZPMC), Changxing Island **Location:** Shanghai, China**CWI Name:** See below**CWI Present:** Yes No**Inspected CWI report:** Yes No N/A**Rod Oven in Use:** Yes No N/A**Electrode to specification:** Yes No N/A**Weld Procedures Followed:** Yes No N/A**Qualified Welders:** Yes No N/A**Verified Joint Fit-up:** Yes No N/A**Approved Drawings:** Yes No N/A**Approved WPS:** Yes No N/A**Delayed / Cancelled:** Yes No N/A**Bridge No:** 34-0006**Component:** Tower and OBG Components**Summary of Items Observed:**

WELDING INSPECTION REPORT

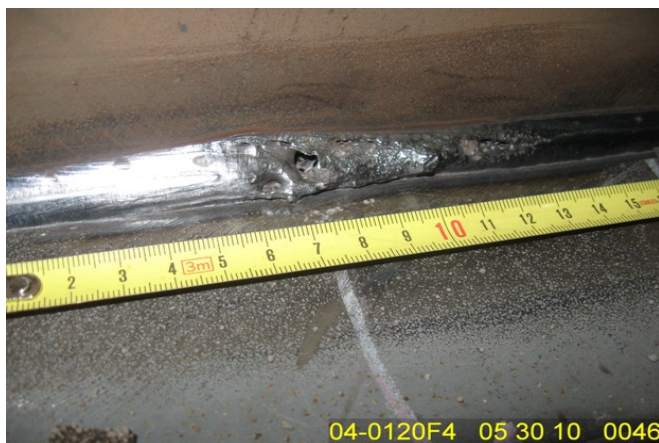
This QA Inspector monitored OBG Production Monitoring Test (PMT) #3081 for deck panels DP3081-001 and DP3078-001 at Gantry #1. Prior to the start of the PMT, this QA Inspector observed the root openings to be within the 0.0 to 0.5mm tolerance. The magnetic particle test (MT) of the tack welds was noted on the test panel as having been performed by ZPMC MT Technician Wang Wei on 5/29/10. The visual inspection of tack welds and root gaps was performed by ABF Representative Wang Wan Cheng (ABF), ZPMC CWI Guo Yanfei (PQC), and this QA Inspector. The tack welds and root gaps appeared to be within prescribed tolerances. This QA Inspector observed that the deck plate of the test panel was 20mm thick and the deck plate of the production panels were 20mm thick. The ambient temperature was approximately 18°C. Flame preheat was applied to the specimens to above 60°C immediately prior to start of the gas metal arc welding (GMAW) pass. The interpass temperature was checked between processes and observed to be above 60°C. The start time for welding of the 2–12mm x 20mm specimens was approximately 0010 hours on 5/30/10 and the finish time was approximately 0034 hours. This QA Inspector randomly verified and documented the welding amperage, voltage, and travel speed during the gas metal arc welding (GMAW) and submerged arc welding (SAW) processes, and performed a visual inspection welds 1 thru 4 at the completion of both the GMAW root pass and SAW cover pass. The welding variables recorded by PQC appeared to comply with WPS-B-T-2342-U1-(U-rib)-5. The welds were visually inspected by ABF, PQC and this QA Inspector. PQC and ABF informed this QA Inspector that weld #3 appeared to burn through the back side of the root pass resulting in what appeared to be major porosity and incomplete fusion, not in conformance with contract documents and were not acceptable. See photo below. PQC rejected the test and this QA Inspector concurred.
